BLOCKAGE OF FLAME CONTROL DEVICES: DESIGN AND
MAINTENANCE CRITERIA

Arthur D. Little, Incorporated

Report No. CG-D-158-75

**DEPARTMENT OF TRANSPORTATION
UNITED STATES COAST GUARD**

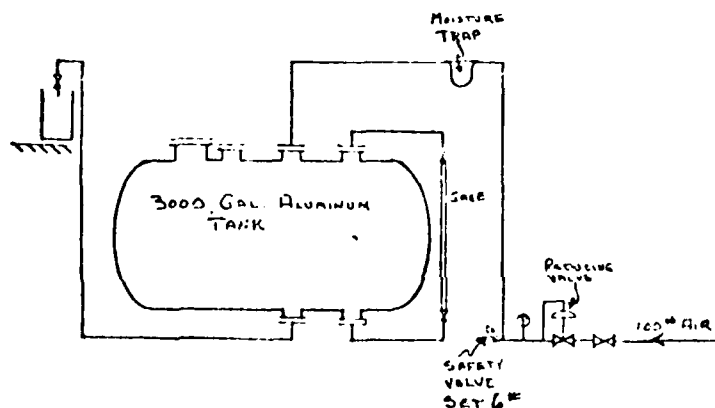
CASE HISTORY NO. 1192

The scale, dirt, and moisture from the vertical pipe and the horizontal run was driven into the elbow and the Safety Valve opening each time the system was pressurized. Finally the elbow and valve became plugged so that when the Reducing Valve leaked, the Safety Valve could not function. One head was blown out of the tank with enough force to remove 1000 square feet of window, a portion of the roof, and the brick chimney of the adjacent building. Fortunately the injuries were minor but the property damage was extensive.

Preventive Measure: A Safety Valve should be located to minimize the amount of foreign material that can accumulate in its fitting or entrance. In this case it could have been off a tee in the vertical riser, or at the top of the riser. Such valves should be removed and the valve and fittings checked on a periodic basis.
